**MONTHLY REPORT 20 / August 2021**  
**for**  
**COSMOPOLIS PROJECT - ROMANIA**

## ANNEX 1

### Site Photos and Notes for August 2021

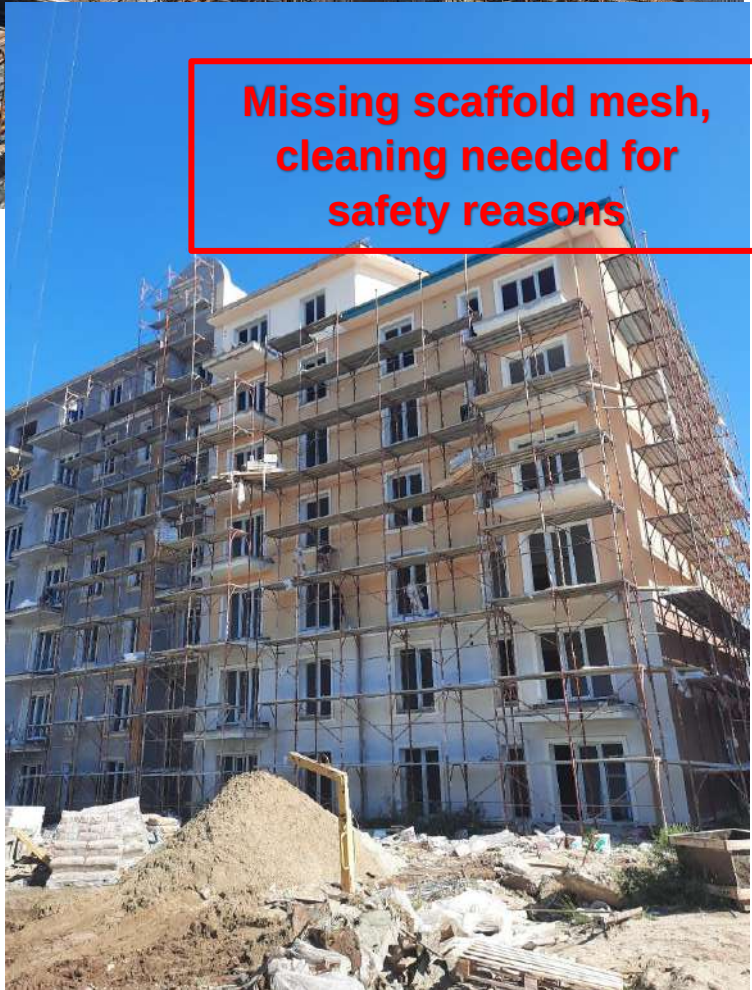
**Missing scaffold mesh,  
cleaning needed for  
safety reasons**

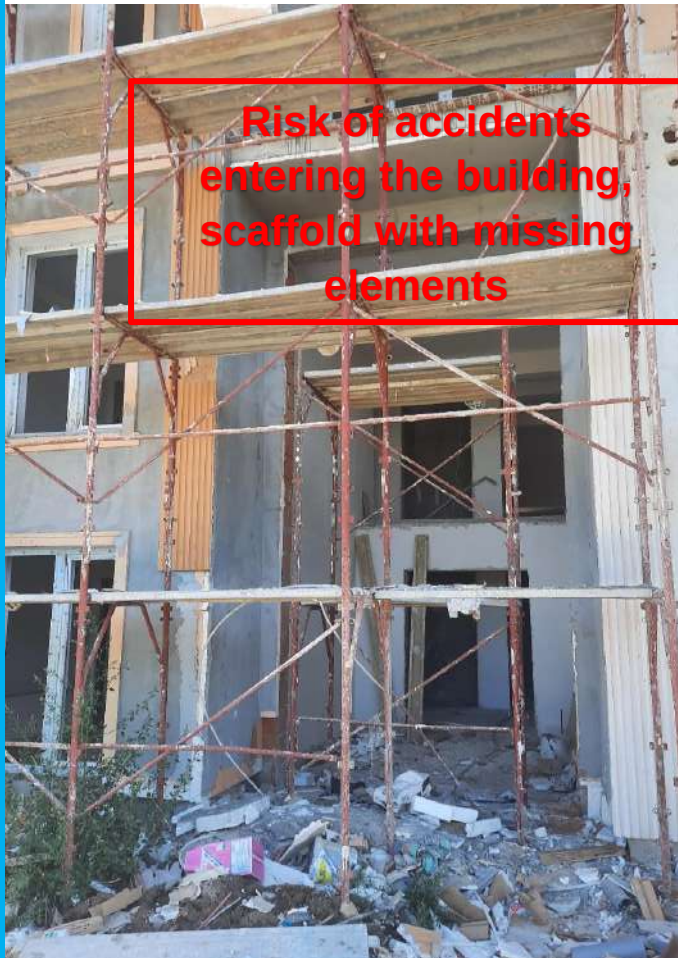
**Risk of accidents  
entering the building,  
scaffold with missing  
elements**

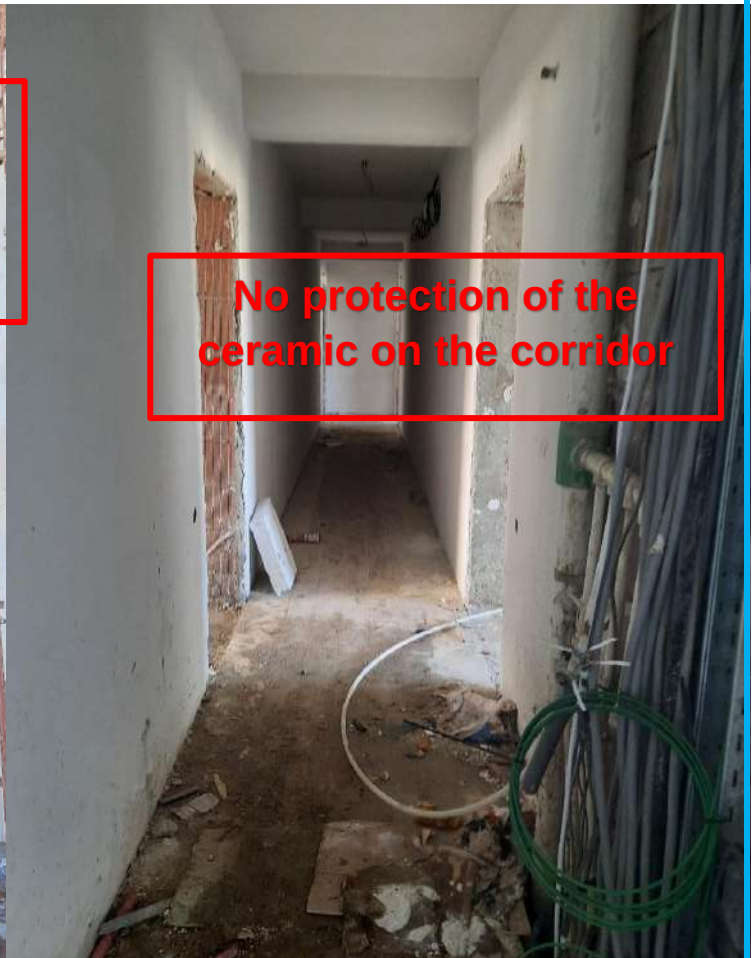
**No protection of the  
ceramic on the corridor**

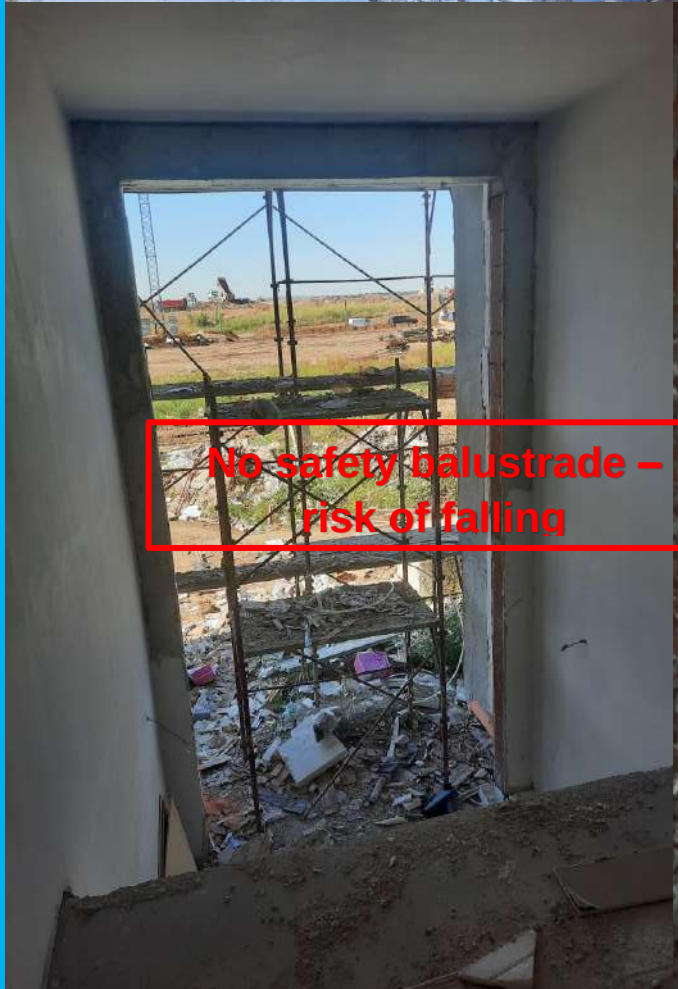
**No safety balustrade –  
risk of falling**

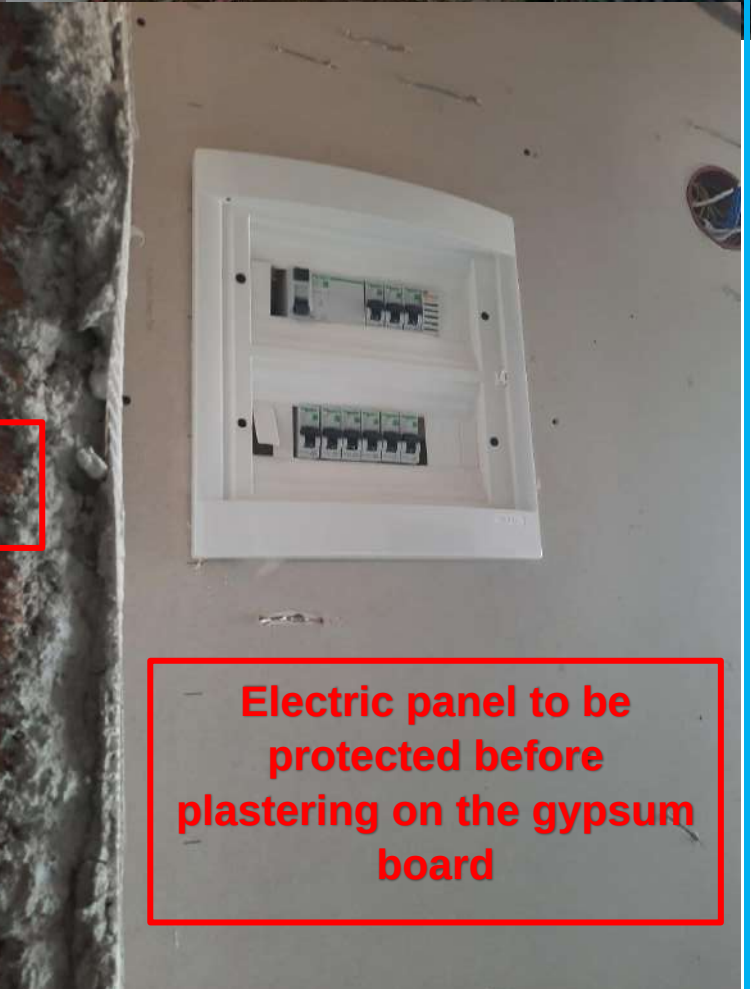
**Electric panel to be  
protected before  
plastering on the gypsum  
board**

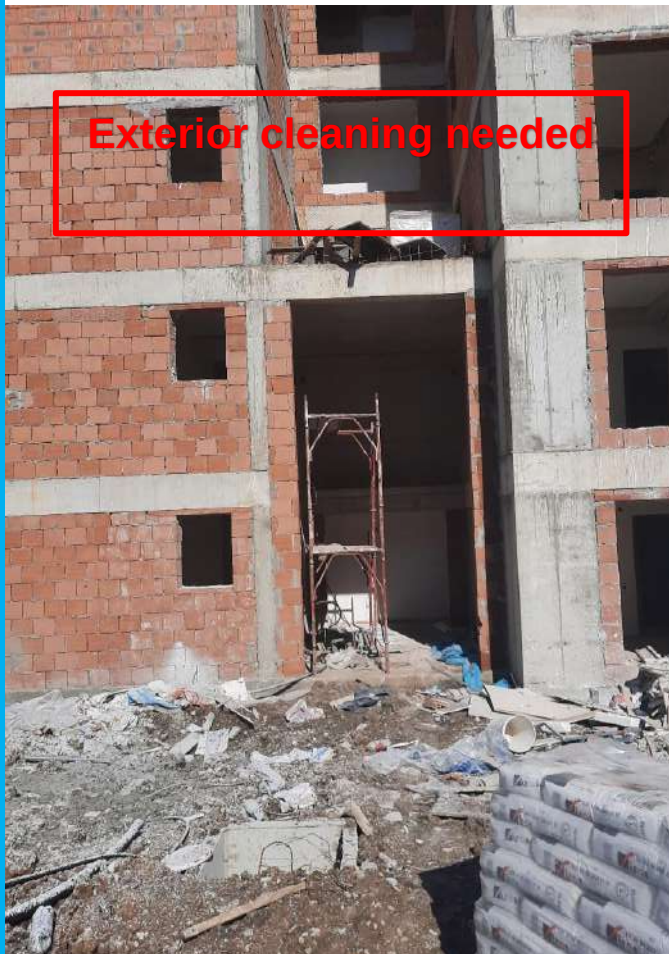
**Exterior cleaning needed**

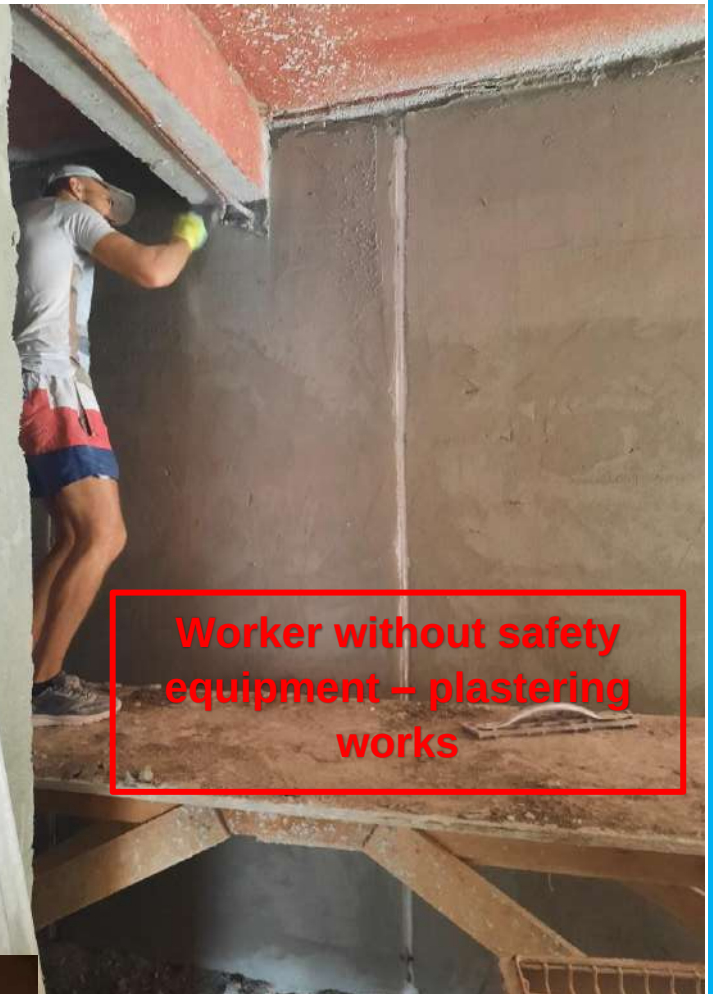
**Worker without safety equipment – plastering works**

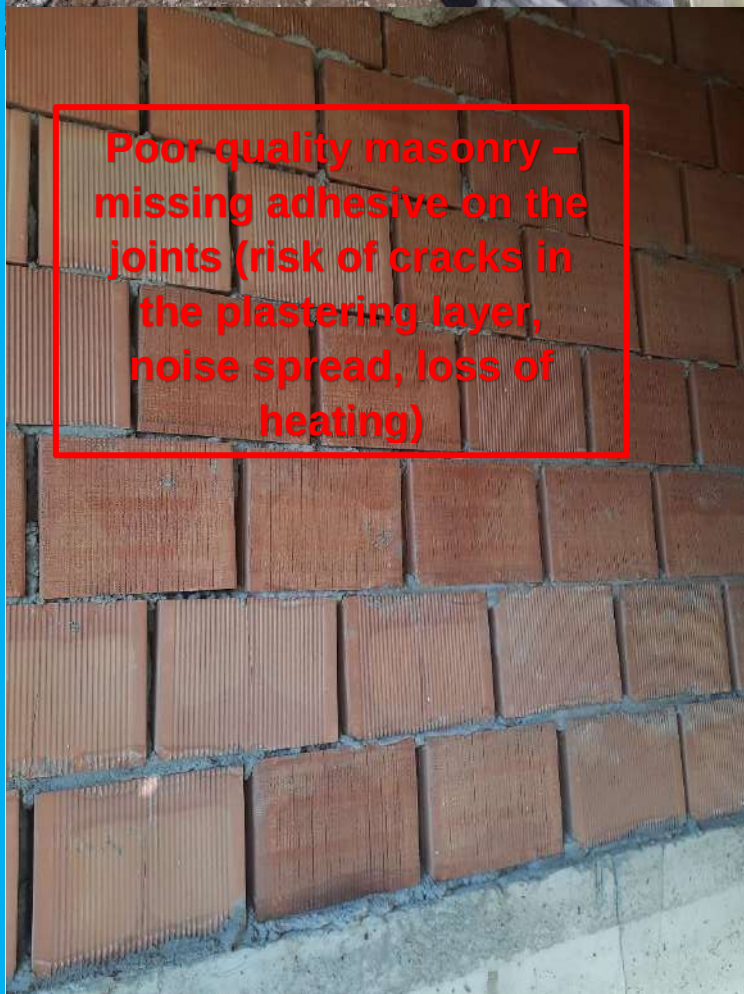
**Poor quality masonry – missing adhesive on the joints (risk of cracks in the plastering layer, noise spread, loss of heating)**
